Cycling and Health Tech Industry R&D Center, Testing Laboratory

Test Report

Product: Front fork

Model : TM-1

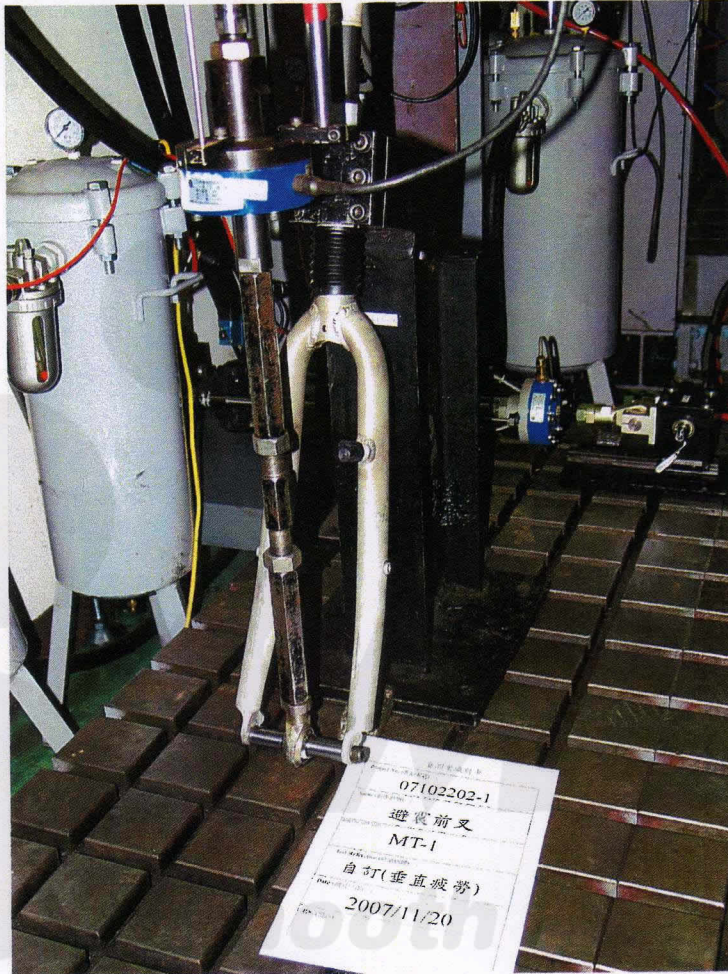
Fig. 2 Bending fatigue test

The tested fork has no crack or fracture by the test. (Fig.2).
